## SERVICE BULLETIN

### NO. A3312-71-2

POWER PLANT - FAN COWL - HOLD OPEN ROD  
REPLACE DAMPER GUIDE ROD

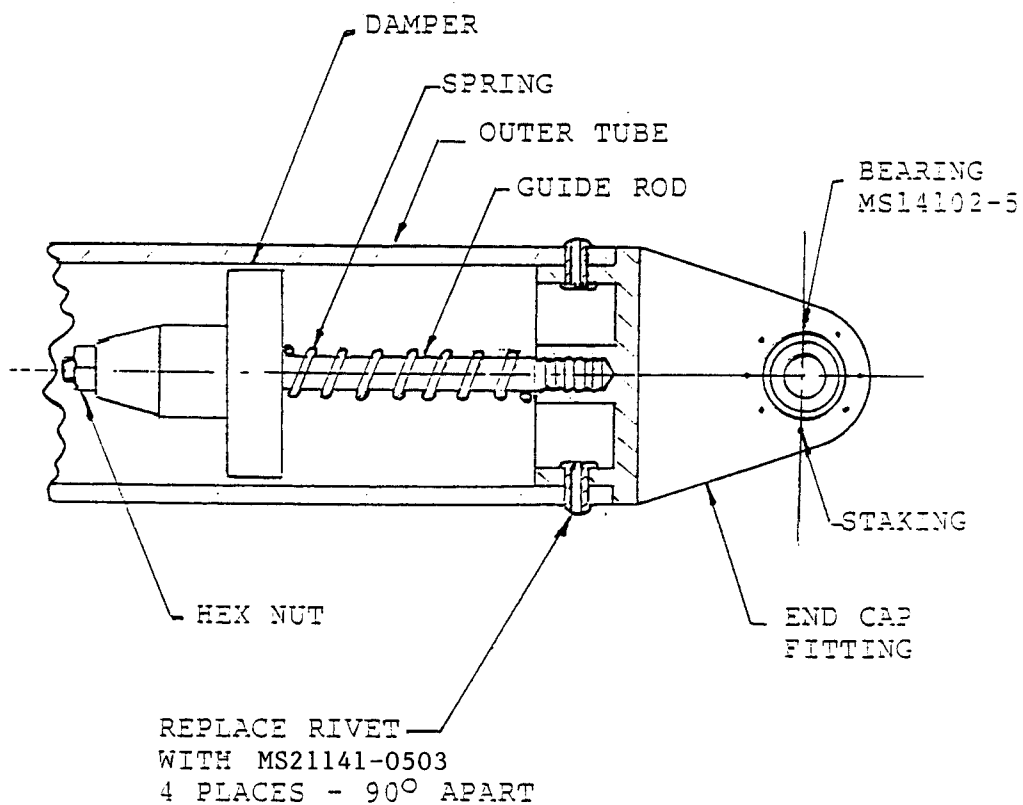
FIGURE 1 - END CAP ASSEMBLY AND DAMPER

The incorporation of this Service Bulletin will prevent bending of the damper guide rod which has resulted in difficulty to fully retract the hold open rod.

- C. Drill out four (4) rivets in outer tube, shown in Figure 1, using a No. 19 drill, .166 inch (4.216 mm) diameter. Center drill point in center of rivet. Drill only deep enough until rivet head separates from stem. Tap remaining rivet into outer tube.

- D. Remove end cap assembly from end of outer tube. Remove hex nut, damper, and spring from guide rod and save for use in new end cap assembly.
- E. Remove spherical bearing, MS14102-5, from end cap assembly by pressing out. Press bearing into new end cap assembly, AM3312-2-50, and stake at 8 points equally spaced around both sides of the bearing housing. The staking tool should have a spherical radius of .093 - .108 inches (2.362 - 2.743 mm) and produce a .010 - .015 inch (.254 - .381 mm) indentation located .050 - .060 inches (1.270 - 1.524 mm) from the O.D. of the bearing.

- F. Insert end cap assembly into end of outer tube and align rivet holes with pilot holes in end cap assembly. Drill out holes in end cap assembly using a No. 19 drill .166 inch (4.216 mm) diameter and holes in outer tube as pilot holes.

- J. Place end cap assembly back into end of outer tube and align rivet holes using marks placed on outer tube and end cap assembly.
- K. Apply primer TT-P-1757 and install four (4) MS21141-0503 rivets using a double action tool as indicated in Military Standard MS21141.
